# Manhole Inspection Summary

Manhole # S19II\_020MH

Insp Date: **6/20/07 12:37 PM**

**Location** Address: **1624 PULASKI ST**

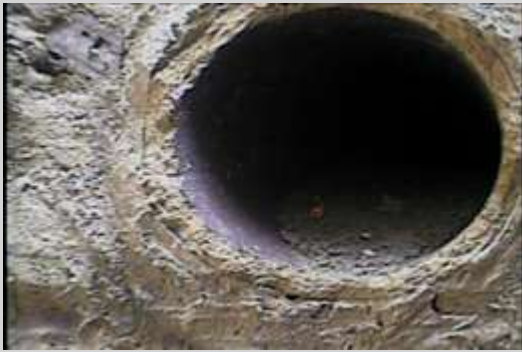
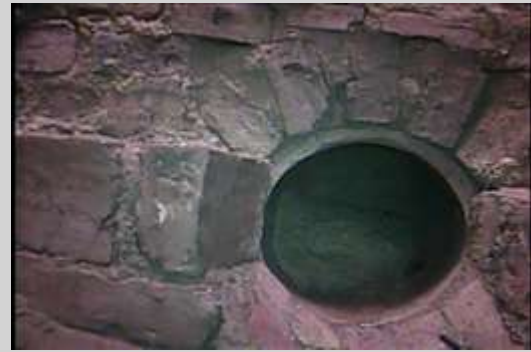
9 O'Clock Inflow

Pipe Height: **8.4** (in.) Rod and Bar (Angled)

Pipe Material: **Clay** ☐ Pipe Lined

Infiltration: **None** Pipe Seal Cond: **Sound**

Drop Condition: **Open**
